**Measures Addressing Aftermath of Boiler Breakage at Our Subsidiary Iwaki Daio Paper Corporation  
(3rd Report)**

(Attachment) Report on Investigation of Explosion Accident Involving In-house Power Generation Equipment at Iwaki Daio Paper Corporation

# Iwaki Daio Paper Corporation

## Report on Investigation of Explosion Accident Involving In-house Power Generation Equipment

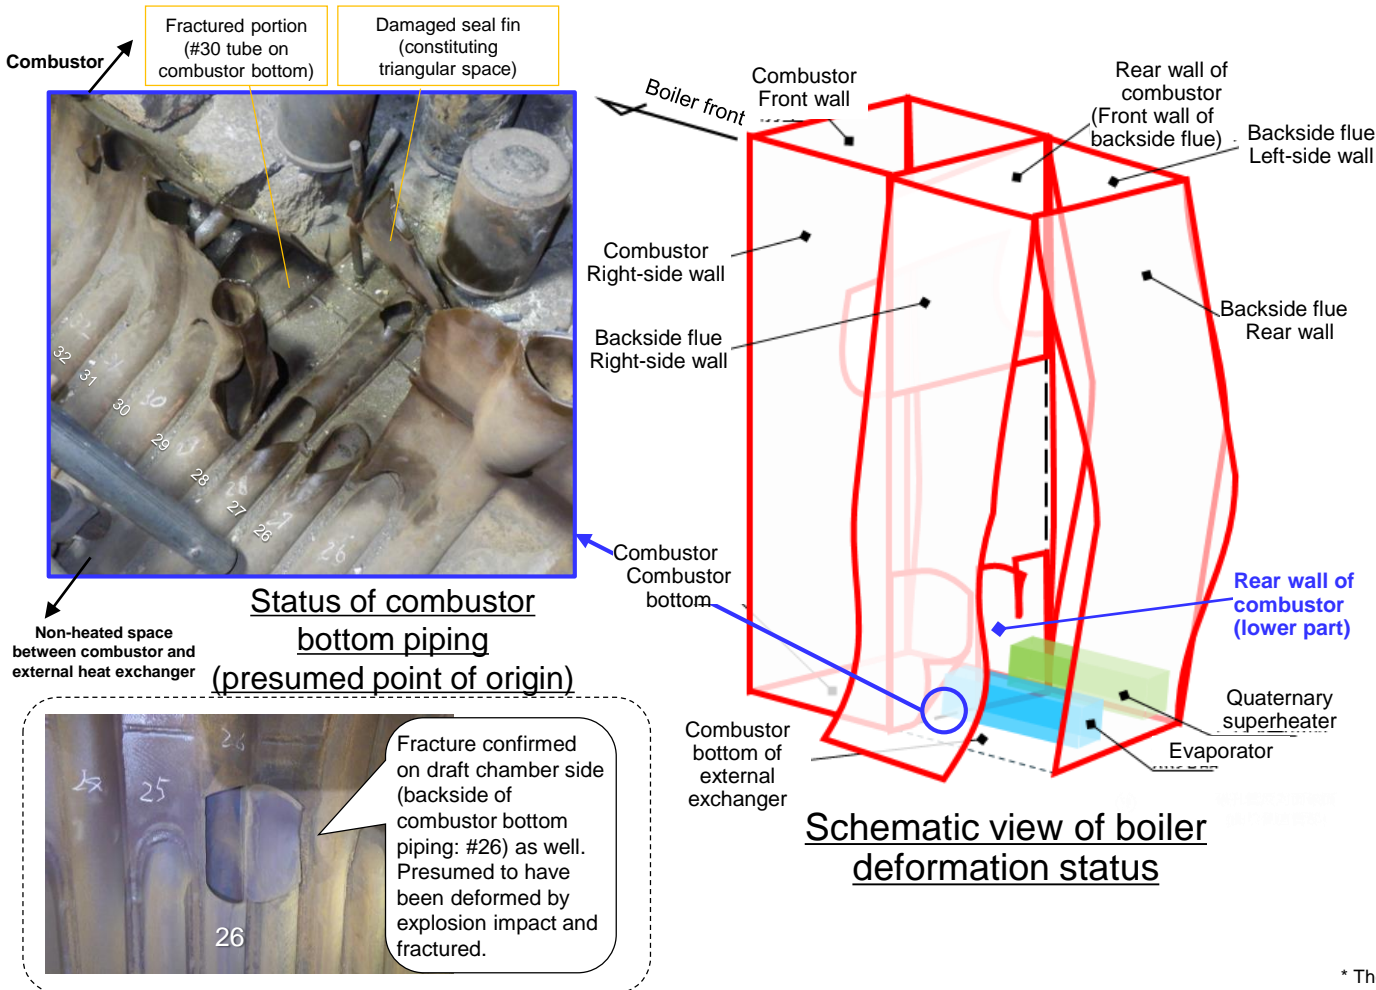
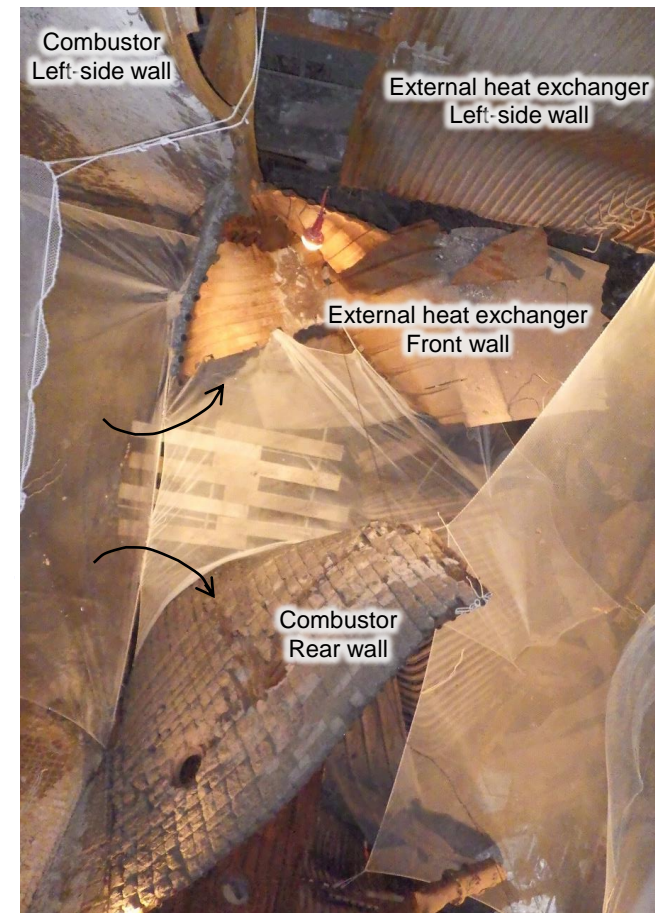
- We have found the lower part of the combustor's rear wall to have greatly deformed and fractured toward the external heat exchanger side (the boiler's back side), showing signs of enormous power having worked in that direction, with deformation near the bottom of the combustor most remarkable.
- While there are a majority of tube fractures forced by the explosion, we have presumed the furnace bottom tube #30 (the 30th pipe from left), which shows a fracture caused by internal pressure, was the initially fractured portion.

\* The details are subject to change depending on the results of future investigations.

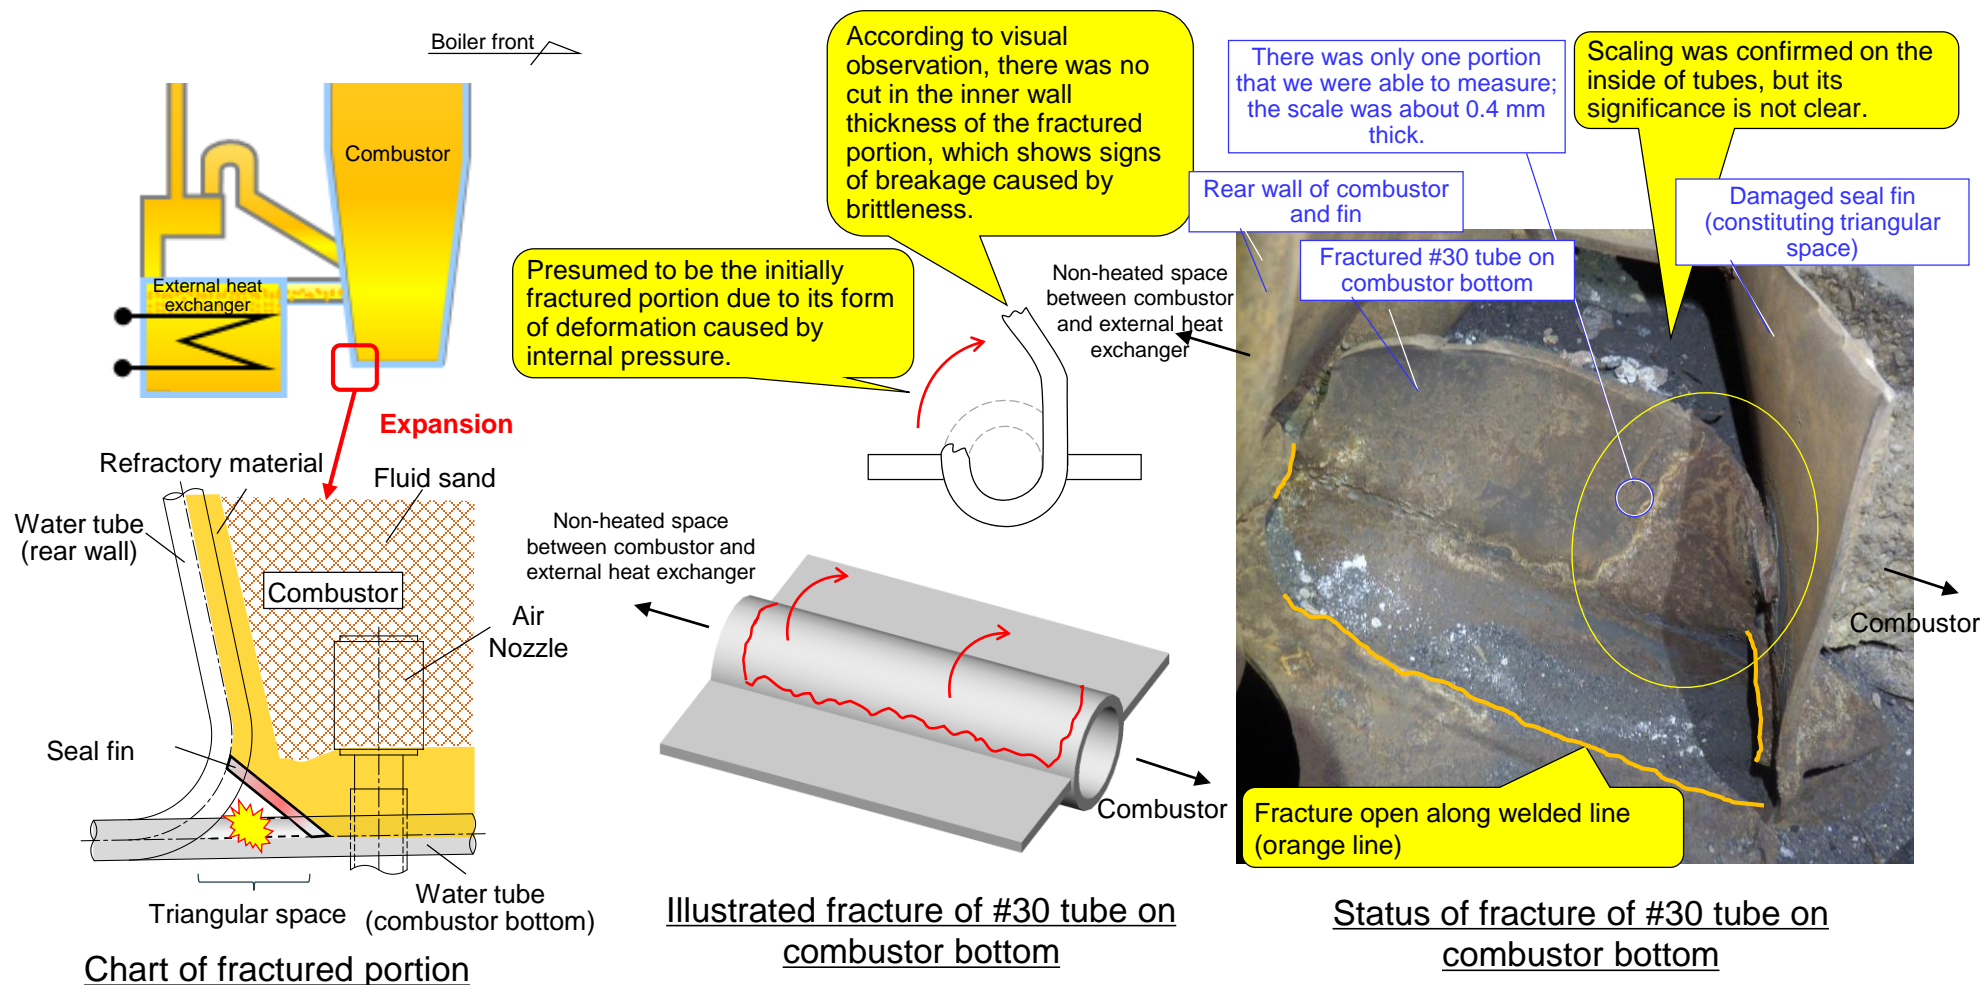
- #30 fractured portion is open, along the welded portion of the seal fin, in the axial/peripheral direction.
- According to visual observation, there was no cut in the inner wall thickness of the fractured portion, which shows signs of breakage caused by brittleness.
- Scaling was confirmed on the inside of tubes, but it is not known if it occurred before the blast.
- #30 fractured portion is within the triangular space where neither sand nor gas reaches, usually due to the seal fin that blocks them.

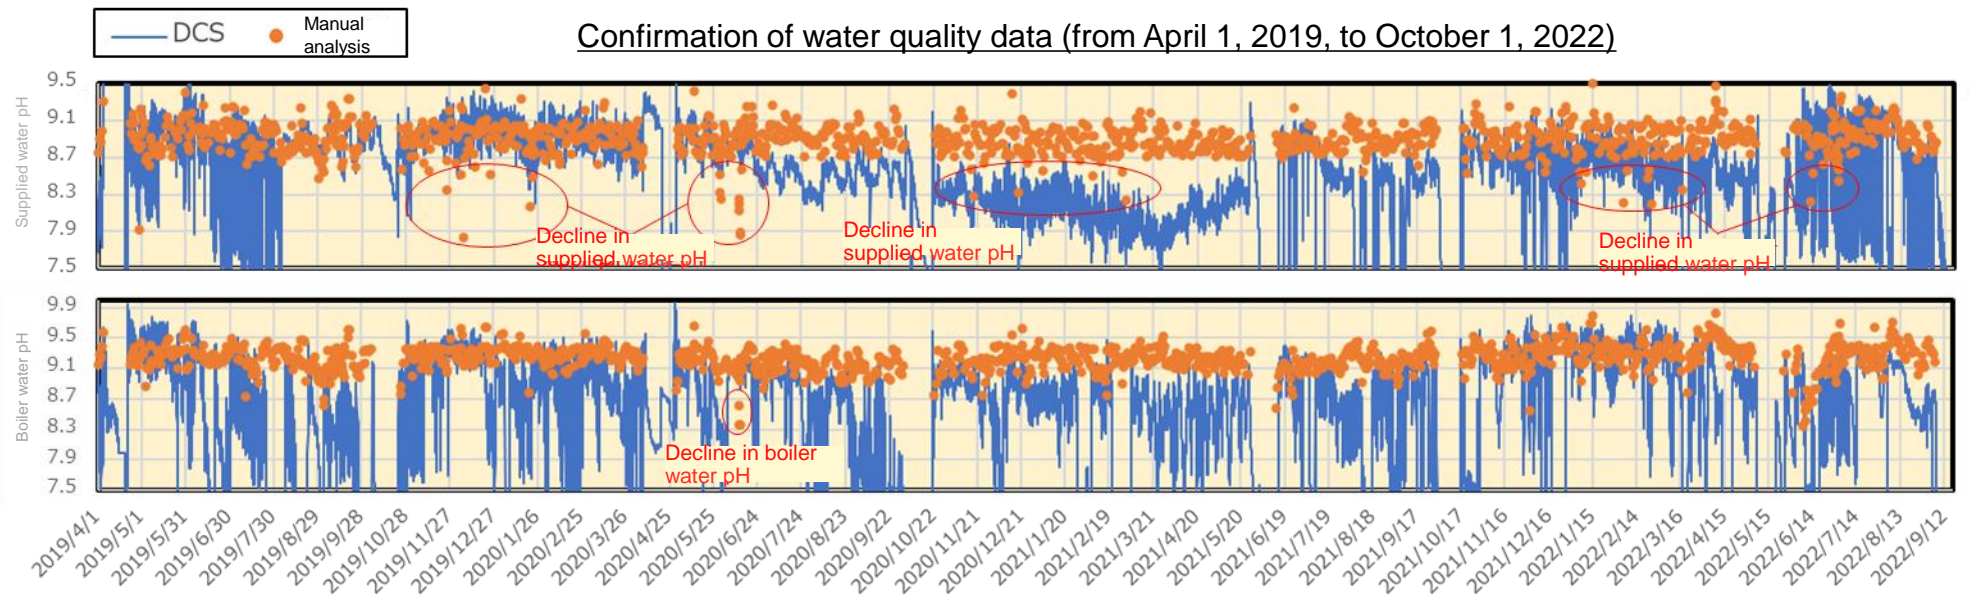
- Water quality used to be managed in accordance with the standards of JIS B 8223. The pH levels of water newly supplied to the boiler and existing boiler water were below the standard of 8.5, as shown in the graphs below.  
The effects of hydrogen corrosion due to deterioration of water quality have been studied on similar parts, and the characteristics of such corrosion have not been confirmed.
- Iwaki Daio routinely conducted manual in-house analysis of pH and conductivity levels once a day as a water quality management practice.  
Readings from a continuous water quality monitoring instrument were used as a reference because they fluctuated widely. Calibration of instruments is performed by an outsourced service provider once every two months.

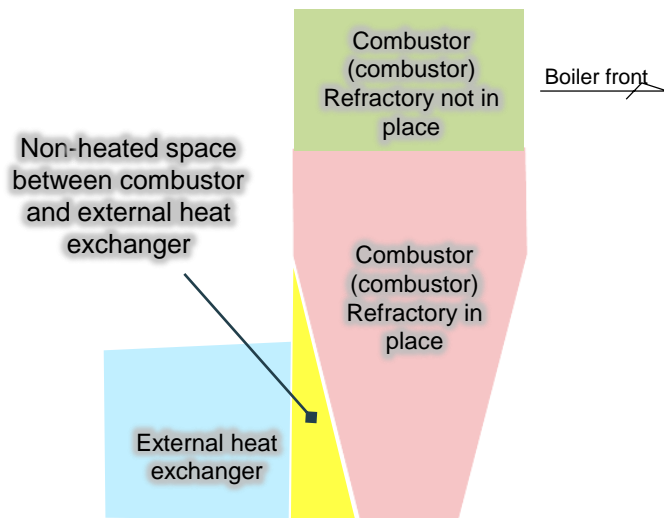
Schematic lateral view of boiler

Water tubes: Inspected water tubes in the upper part of the combustor, not covered by refractory.

Water tubes in areas prone to abrasion were protected with sprayed film, otherwise the tubes were uncovered.

Sprayed film had its thickness measured, and any film with reduced thickness was replaced.

As for uncovered tubes, their exterior appearance was visually inspected and their thickness measured. There was no reduction in their thickness less than the controlled thickness.

Refractory: Uplift displacement and peeling were observed on some of the front and rear walls of the combustor. Partial repair was performed.

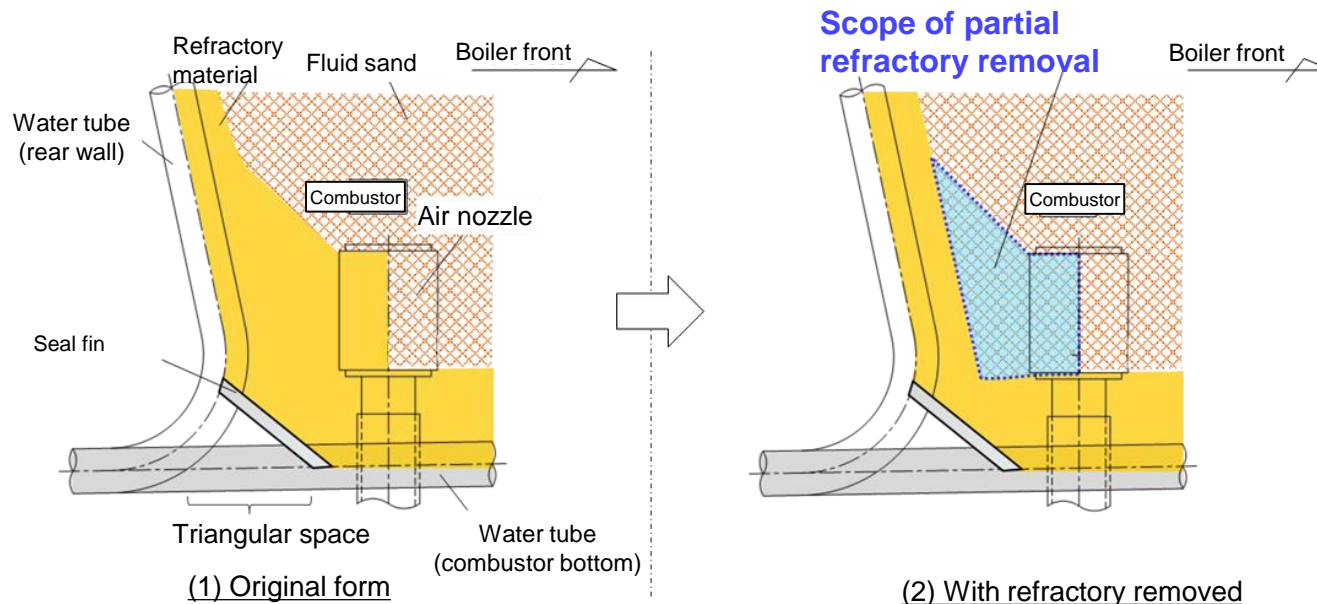
- We evaluated the impact of water tubes exposed by falling out of the refractory material around the triangular space. Even when heat input becomes excessive (exposed to high temperature inside the combustor), a simple increase in heat input alone is not enough to raise the temperature to a level where creep damage occurs, leaving the possibility of boiler breakage low.

- As the scale buildup in the combustor bottom tubes becomes thicker, the metal temperature rises as heat transfer is impaired, increasing the possibility of creep damage. It is not certain that there was any significance in our measurement this time.

\* The details are subject to change depending on the results of future investigations.

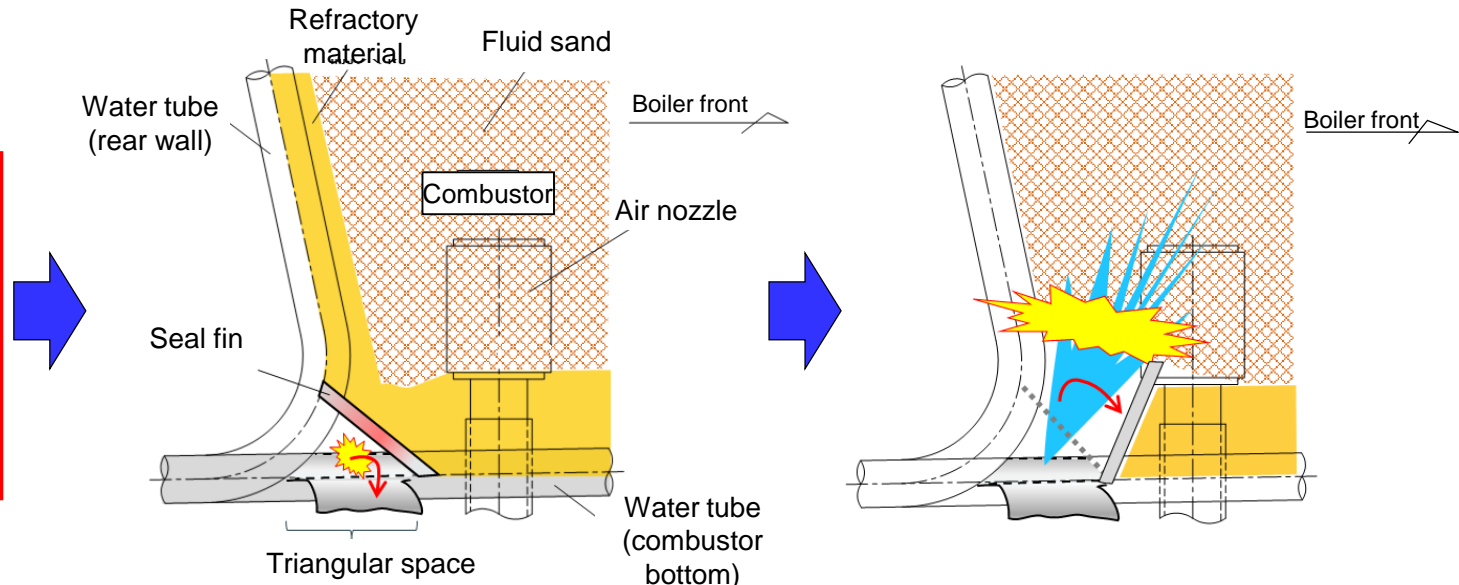
- Since details of the fractured portion of #30 have not yet been analyzed, it is not yet known why the fracture occurred. However, based on the results of the visual inspection and other factors, the following possibility was considered likely: A fracture developed in the #30 tube, causing a large opening in the triangular space to occur instantaneously, causing **a massive amount of water to leak out**, destroying the seal fin, abruptly bringing the water into contact with fluid material containing a large amount of heat, triggering **a steam explosion**, and destroying the boiler.

A situation has arisen in which the following phenomena may occur independently or in combination to **cause water leakage**.

- Corrosion by hydrogen
- Creep damaged
- Crack (fatigue)

Conditions for water leakage to cause an abrupt fracture are present, causing it to occur within the "triangular space" (the large opening resulted in massive **water leakage**)

As **massive water leakage** destroyed the seal fin and came into contact with fluid sand containing high heat, **a steam explosion occurred** on the combustor side, fracturing its rear wall.

- ◎ Eliminate the seal fin for the triangular space (which results in disappearance of the triangular space)
- ◎ Restrict scale buildup on the inside of water tubes (eliminating the risk of creep damage)
- ◎ Prevent decline in pH level of boiler water (eliminating the risk of tube corrosion by hydrogen)
- ◎ Eliminate the risk of heat buildup on water tubes due to refractory removal  
(corrosion by hydrogen, creep damage, avoidance of crack risk)

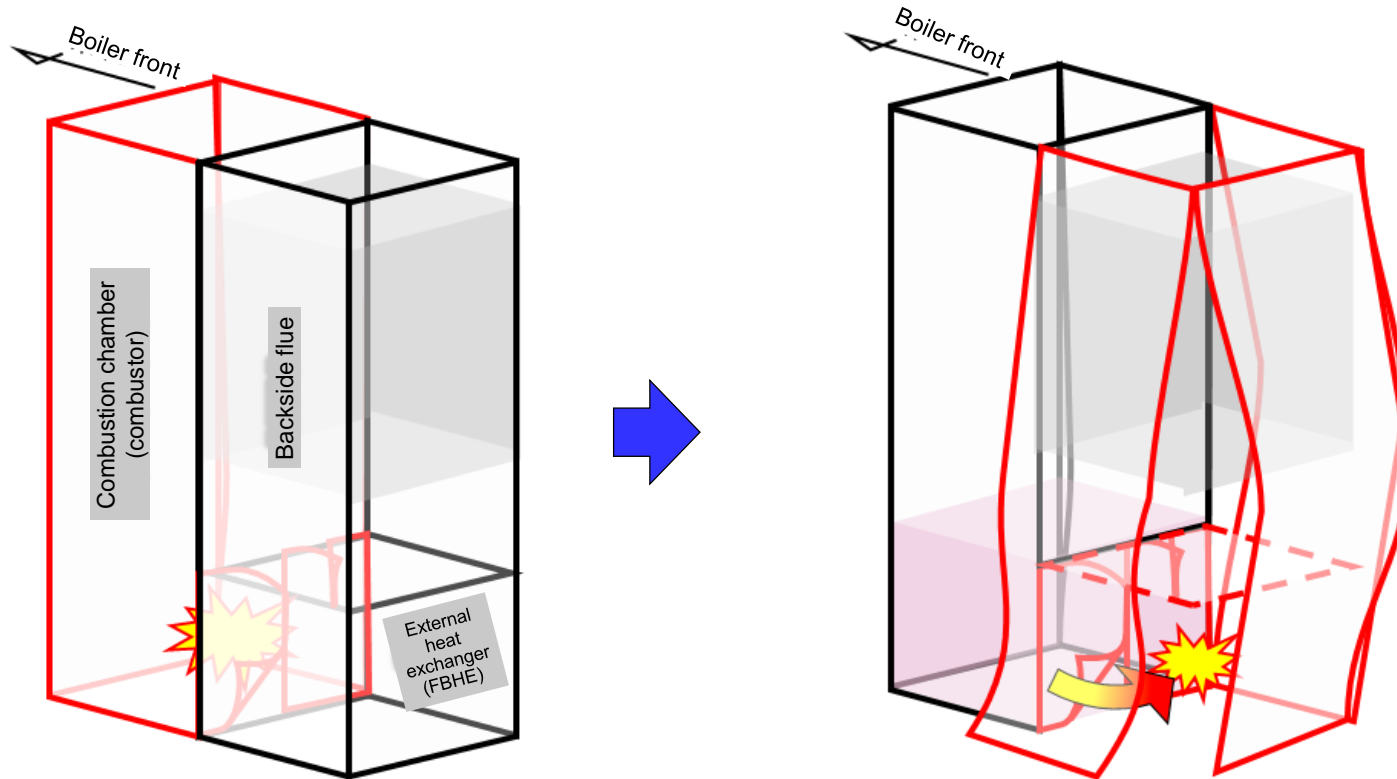
- It is highly probable that **the steam explosion on the combustor side triggered** the fracture of the water tube in the external heat exchanger, causing **a large amount of water** to come into contact with the fluid sand in the external heat exchanger, resulting in **a steam explosion** and further expansion of the damage.

Steam explosion on combustor side fractures water tubes of external heat exchanger, causing **secondary water leakage**

Secondary wave of leaked water comes into contact with fluid sand inside the external heat exchanger, **causing steam explosion** there (**further expanding breakage**).
